Manhole Inspection Summary

Manhole # **S11SS1008MH**

Insp Date: **4/26/07 9:00 AM**

Location Address: **5025 PIMLICO AVE**

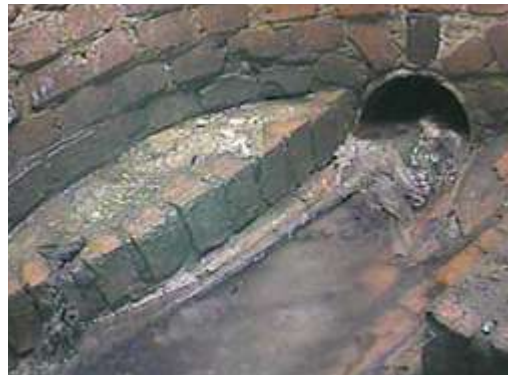
Defect 2

DEBRIS IN CHANNEL

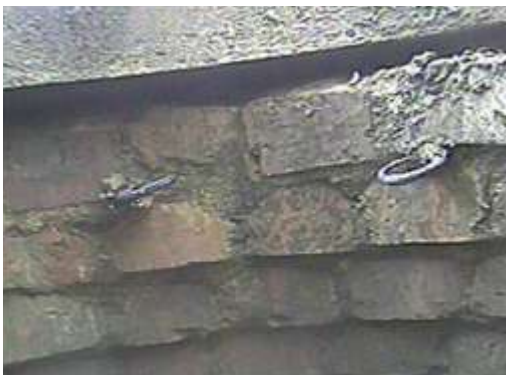
Defect 1

Count: **3** Missing: **1** ☒ **Corroded**

MISSING/ CORRODED RUNG

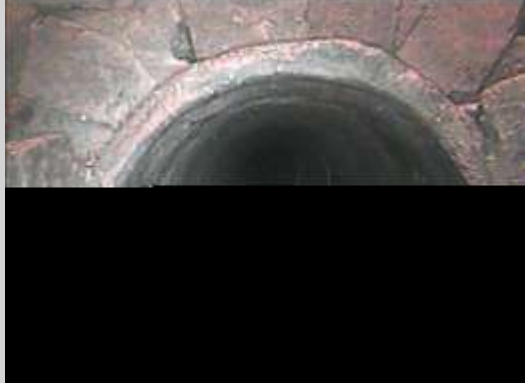
12 O'Clock Outflow

DEBRIS IN CHANNEL

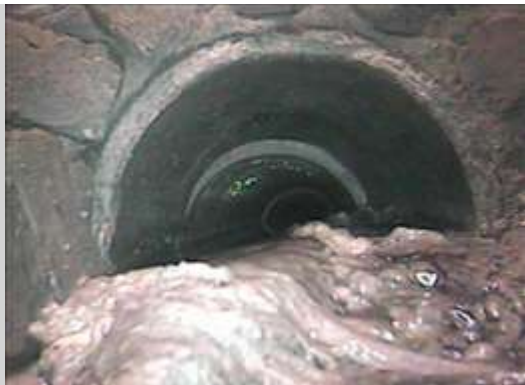
3 O'Clock Inflow

DEBRIS IN CHANNEL

Deposits: ☐ None ☐ Mud ☐ Sludge ☒ **Debris** ☐ Grease

Silt Depth: **2** (in.) Deposits Extent: **Medium**
